## Site 12 Field Work Update

NAVAL STATION TREASURE ISLAND SAN FRANCISCO, CALIFORNIA

Base Closure Team Meeting August 19, 2015

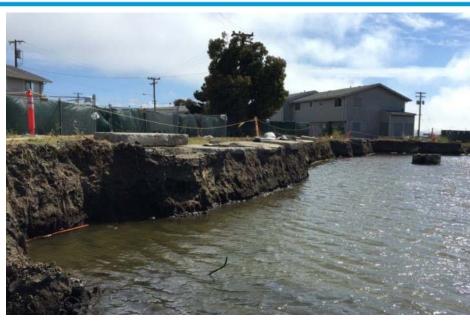
North Point planned excavation boundary complete

Debris found in sidewall and bottom

- May 27: Excavation began
- Buildings 1231 and 1233 foundations removed and soil excavated to 4 feet below ground surface
- 9 LLROs removed to date
- Approximately 5,958 cubic yards have been removed from North Point
- Debris found in some sidewalls and bottom of the excavation and will be removed in late August 2015

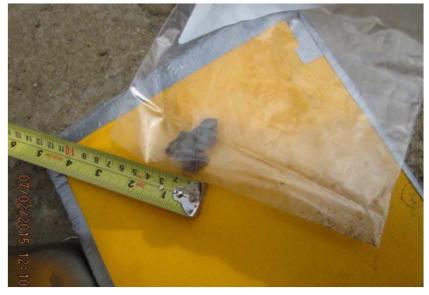
**LLRO 169**

- •9 LLROs extracted to date
- All identified as radium-226

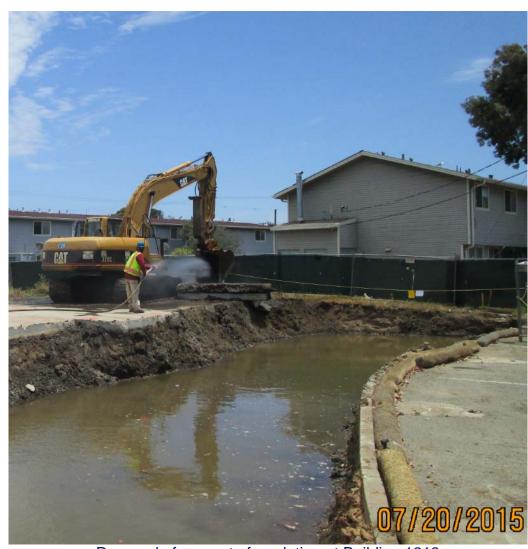
Removal of concrete foundation at Building 1213

- June 26: Excavation began
- Foundations for Buildings 1207, 1209, and 1213 foundations removed and soil being excavated to 4 feet below ground surface
- 55 LLROs has been encountered to date
- As of August 14, approximately 6,449 cubic yards have been removed
- Excavation ongoing

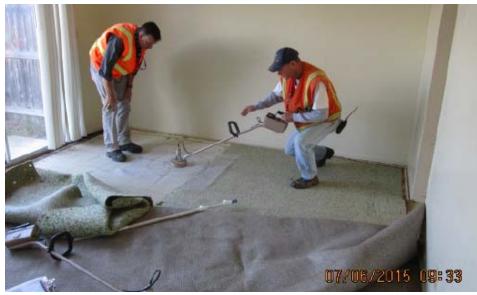
#### Removal: 1240 North Point Drive, Unit D

Survey team confirming location of anomaly before removal of surface material

LLRO appeared to be portion of a gauge

- July 6: Excavated and identified an LLRO at 10 inches below the concrete subfloor
- LLRO was removed
- Surrounding soil was removed and sampled
- July 30: Additional excavation conducted. CB&I and CDPH collected parallel samples at bottom of cavity
- Pending sample results from laboratory, the site will be restored and surveyed again when complete

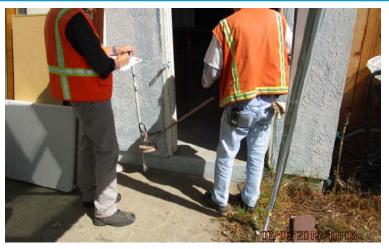
#### Removal: 1241 North Point Drive, Unit B Shed

Survey team confirming location of anomaly before removal of surface material

- July 6: Removed the shed concrete floor, underlying gravel, part of patio surface and shed wall
- LLRO was located within debris of wall removal
- LLRO was removed
- Surrounding soil was removed and sampled
- July 8: Patio and shed foundation restored and post-investigation survey conducted without any elevated readings
- July 24: Sample results showed no elevated readings in soil after LLRO removal.
- Area complete

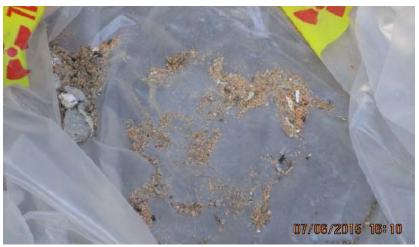
LLRO appeared to be a small piece of metal or paint flake in debris from wall demo

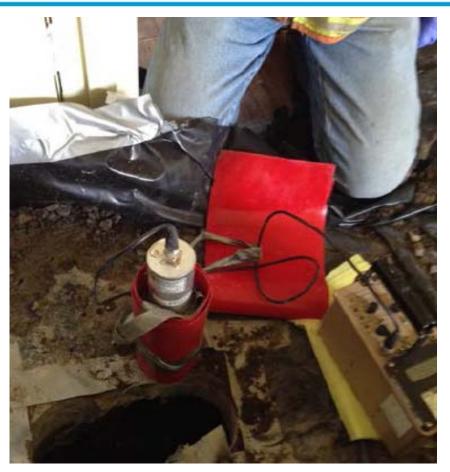
#### Removal: 1303 Gateview Ave, Unit F

One discrete LLRO extracted

Survey team using shielding techniques to get better directional readings from the instrument to assist in locating items generating readings above background

- July 7: Excavated and identified LLROs in soil at about 24" below surface
- Objects and adjacent soil were removed and samples were collected
- July 30: Additional excavation conducted.
   CB&I and CDPH collected additional samples along sidewall.
- Pending sample results from laboratory, the site will be restored and surveyed again when complete
